Combat Corrosion by Design

By John L. Campbell

John Campbell uncovers several examples of poor design methods that induce or speed up the corrosive process.

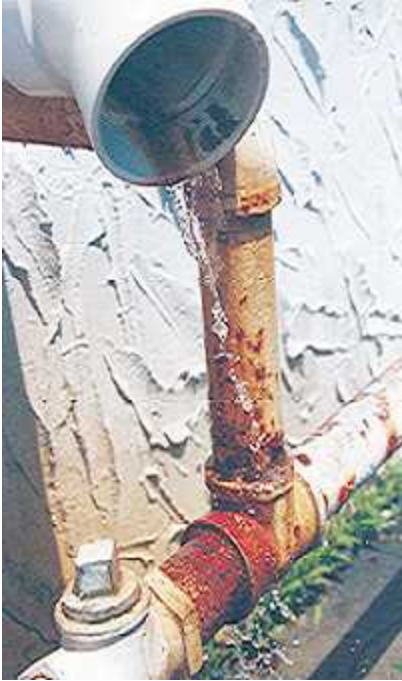
Careless construction carries rain water off a flat roof onto steel pipe that supplies natural gas to a restaurant.

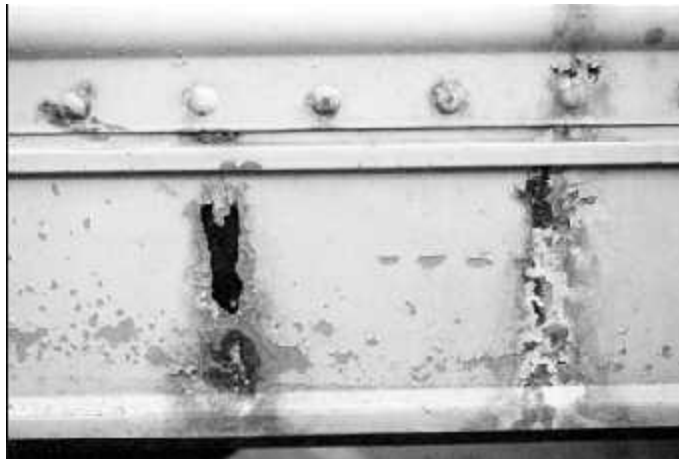
The steel support frame on a commercial trailer is corroding the aluminum skin, an example of coupling dissimilar metals and the resultant galvanic corrosion.

- A nonprofit organization collects clothing and discarded items in the parking lot of a nearby supermarket. Their trailers are old, probably donated equipment, not meant for long hauls. Nevertheless, the aluminum skins on the trailers show evidence of their steel frames underneath. The aluminum, being anodic to the steel, is eaten away leaving traces of the steel frames showing through the trailers' exterior skin.
- In your basement you'll probably find a brass valve or fitting threaded directly to steel or iron pipe without an insulator coupling. In my garage I see inexpensive gardening equipment using steel rivets to join aluminum plates. Even worse would be aluminum rivets to attach steel plates.

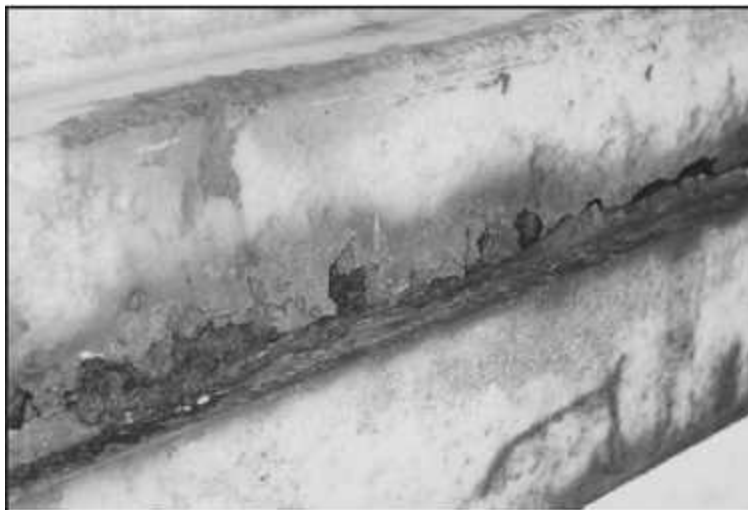
Crevice corrosion occurs where moisture accumulates to become the electrolyte between overlapping metal surfaces. A difference in electrical potential builds up between the oxygen deprived crevice (anodic area) and the surrounding surface (cathodic) exposed to the air.

A deep nick or scratch on a metal surface will become anodic to the surrounding area and propagate itself. Likewise a difference in oxygen content causes a concentration cell where metal sheets overlap to form a crevice.

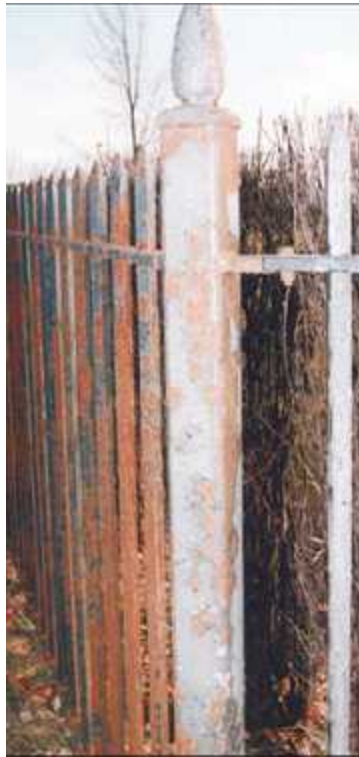
This steel fence, which is set back from a main thoroughfare about 20 feet, illustrates the corrosive effects of road salt used in northern communities to melt ice and snow.

would have the same affect. Where one area is starved of oxygen it will become anodic to the adjacent surfaces exposed to air. Any design to combat corrosion is without relevance until the fabricator knows how and where the product is going to be used. After you've considered all possibilities, and taken all the precautions of good design, unforeseen circumstances can still arise. Strong winds carry the corrosive effects of sea water, which is why coastal areas are hot spots for accelerated corrosion; but the corrosive nature of street salt can be just as deadly. For instance, thousands of miles from either ocean, an iron picket fence rusted due to winter salt spray created by fast moving vehicles on a nearby thoroughfare.

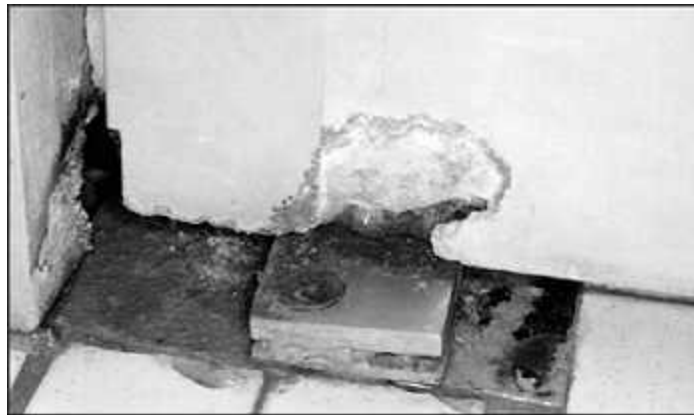
The combination of high humidity in a chlorine atmosphere accelerates the galvanic action between an aluminum door and a chromium plated bronze swivel plate at an indoor pool.
